Debris/Ice/TPS Assessment And Photographic Analysis For Shuttle Mission STS-48

November 1991

Gregory N. Katnik
NASA/Kennedy Space Center

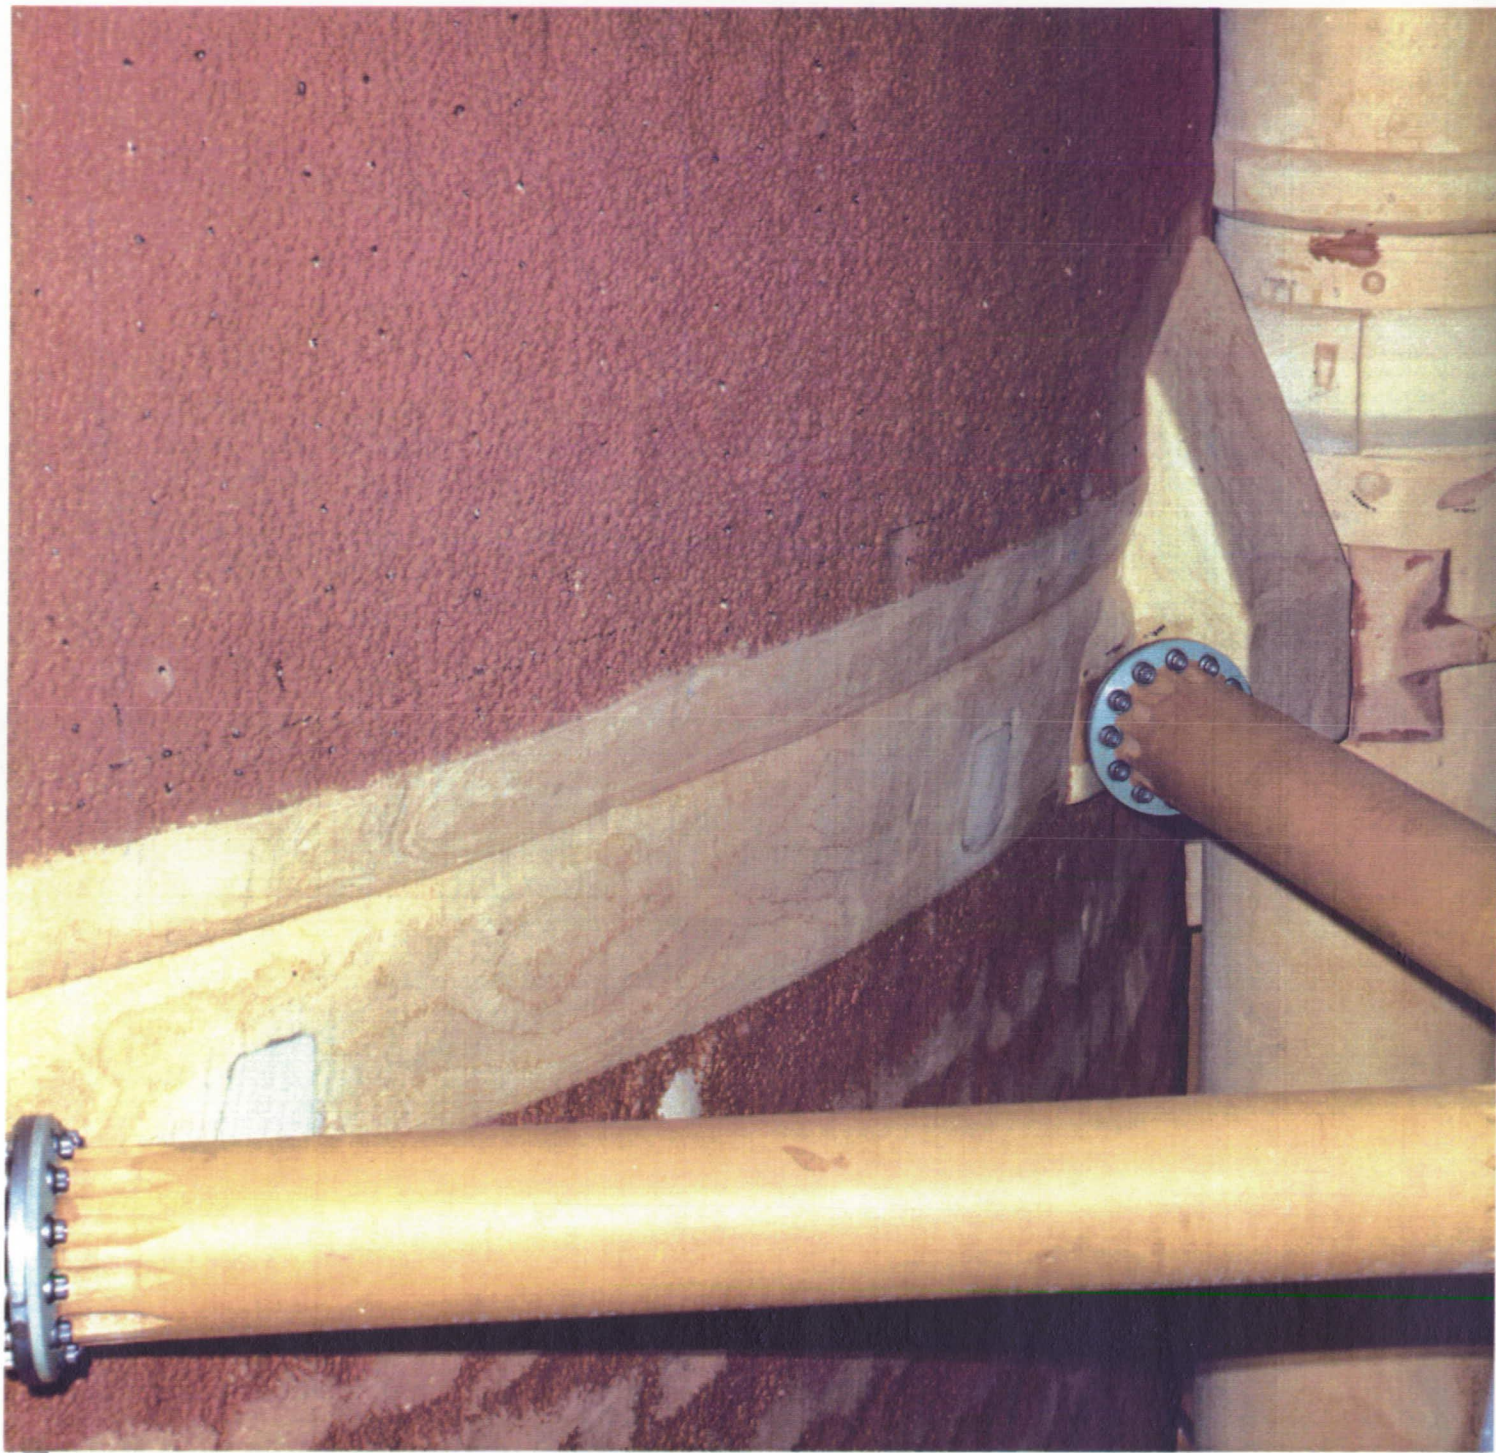
Bipod jack pad closeouts prior to cryogenic loading

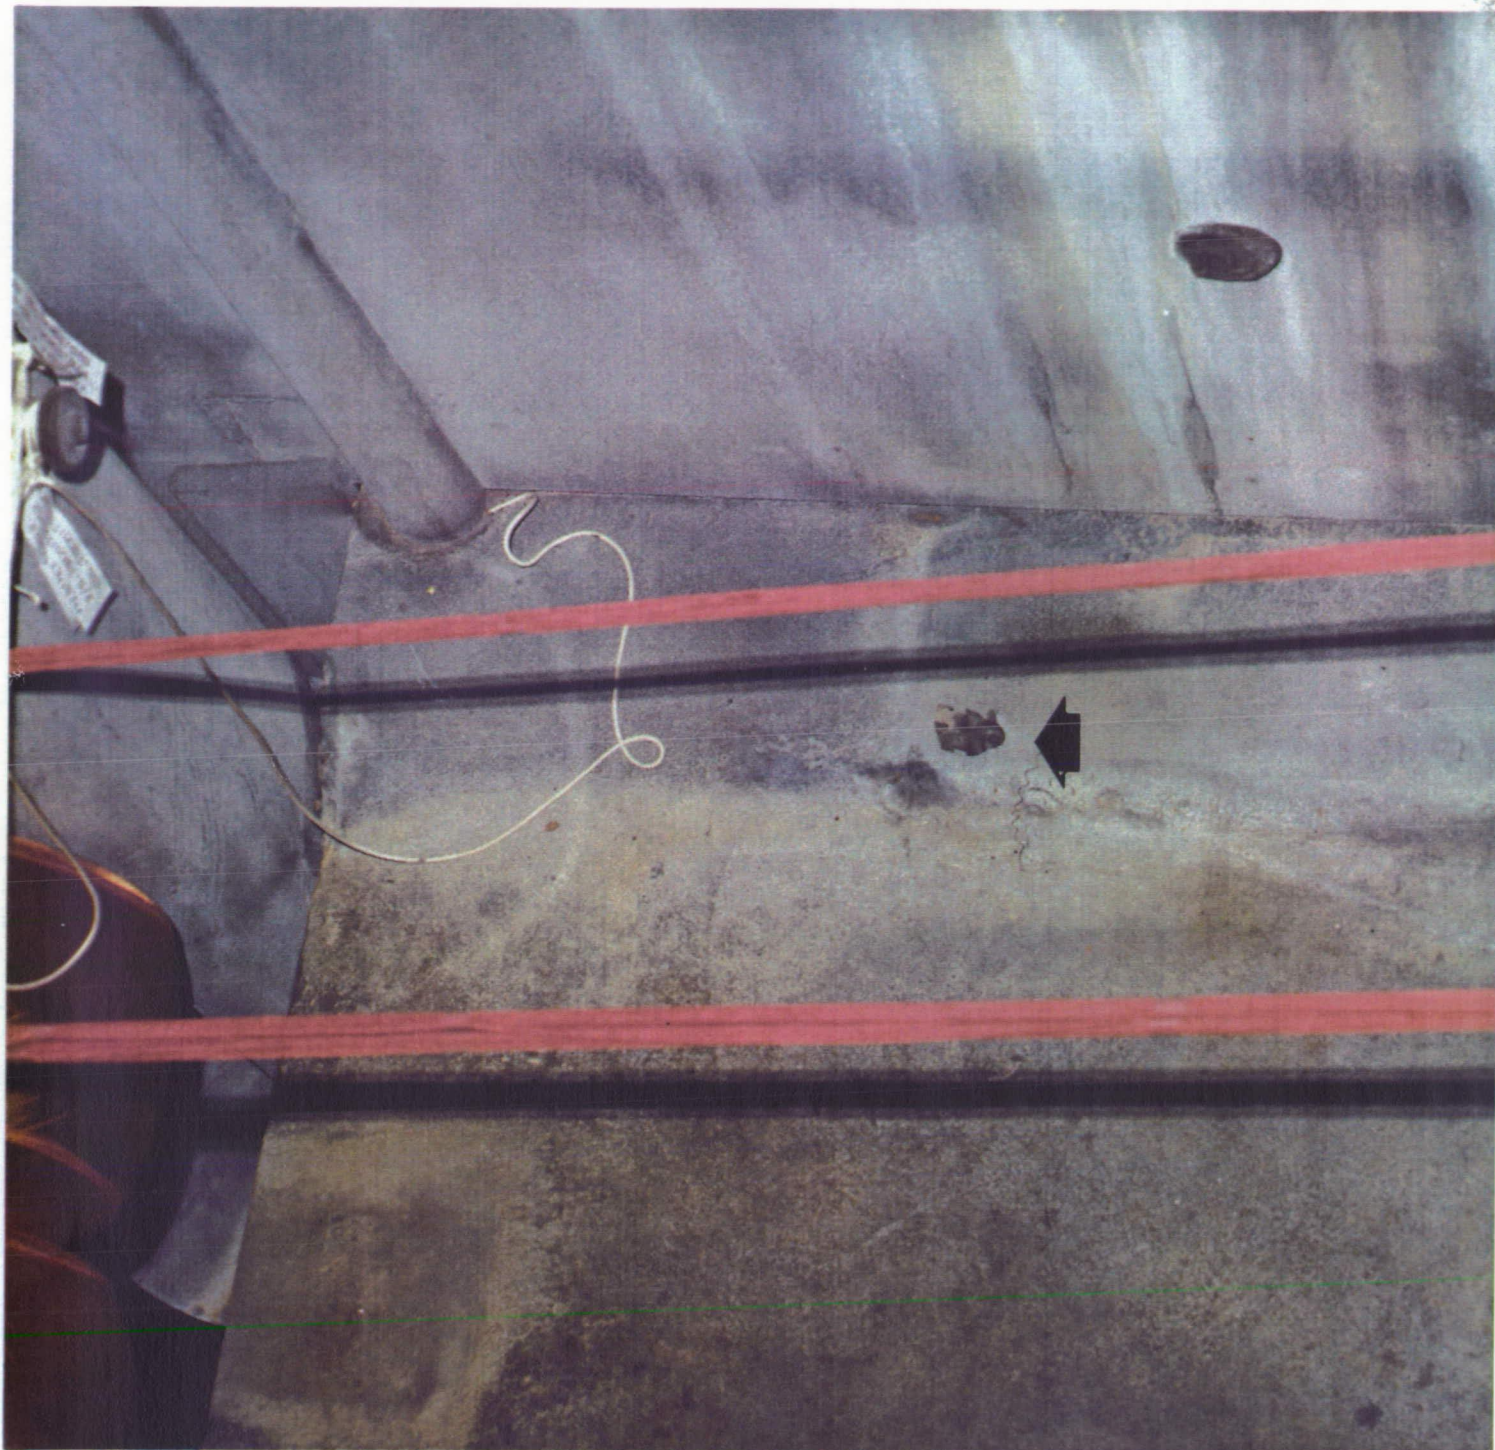
Universal metal clamp lay on the holddown post haunch near the
base of HDP #5

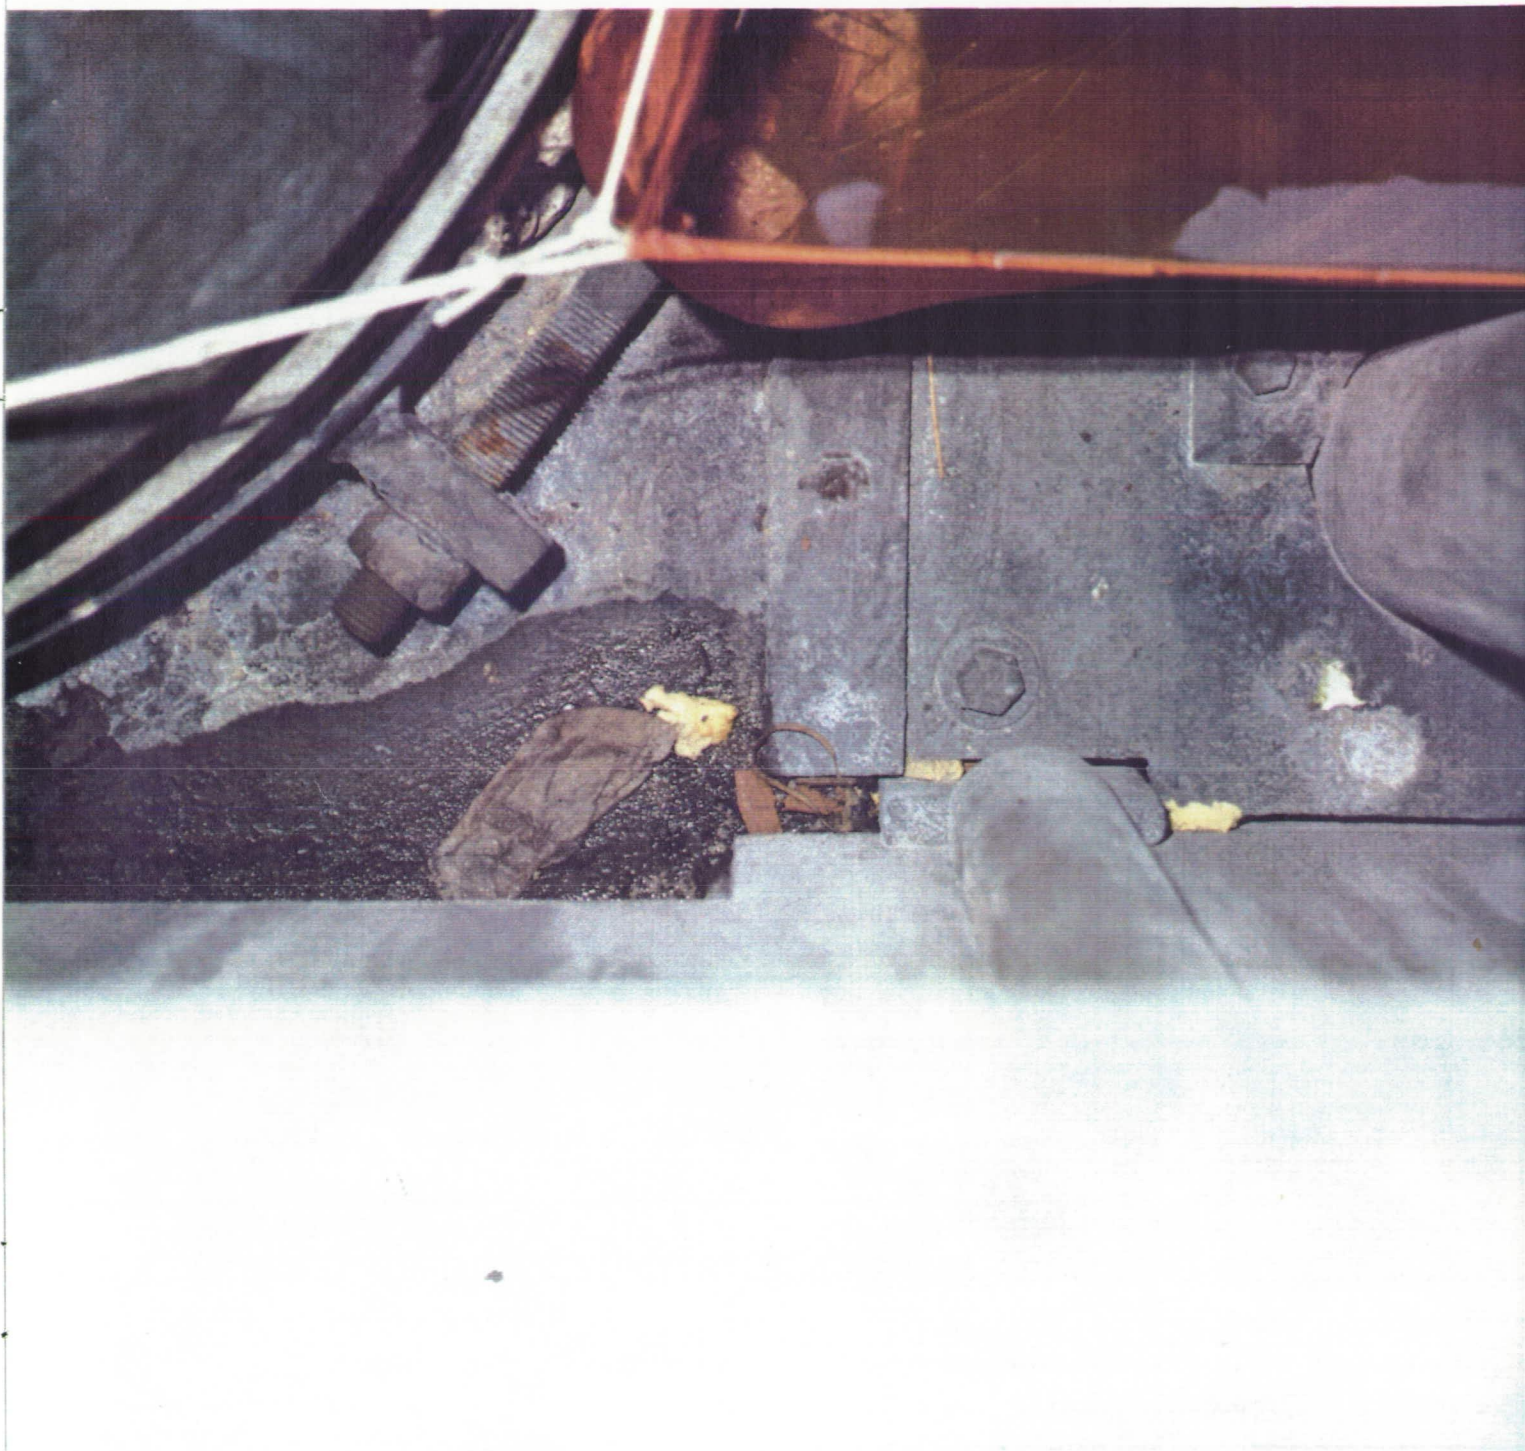
K5NA and instafoam trimmings, tie wrap pieces, and other debris were present around the bases of the south holddown posts and in the haunch areas

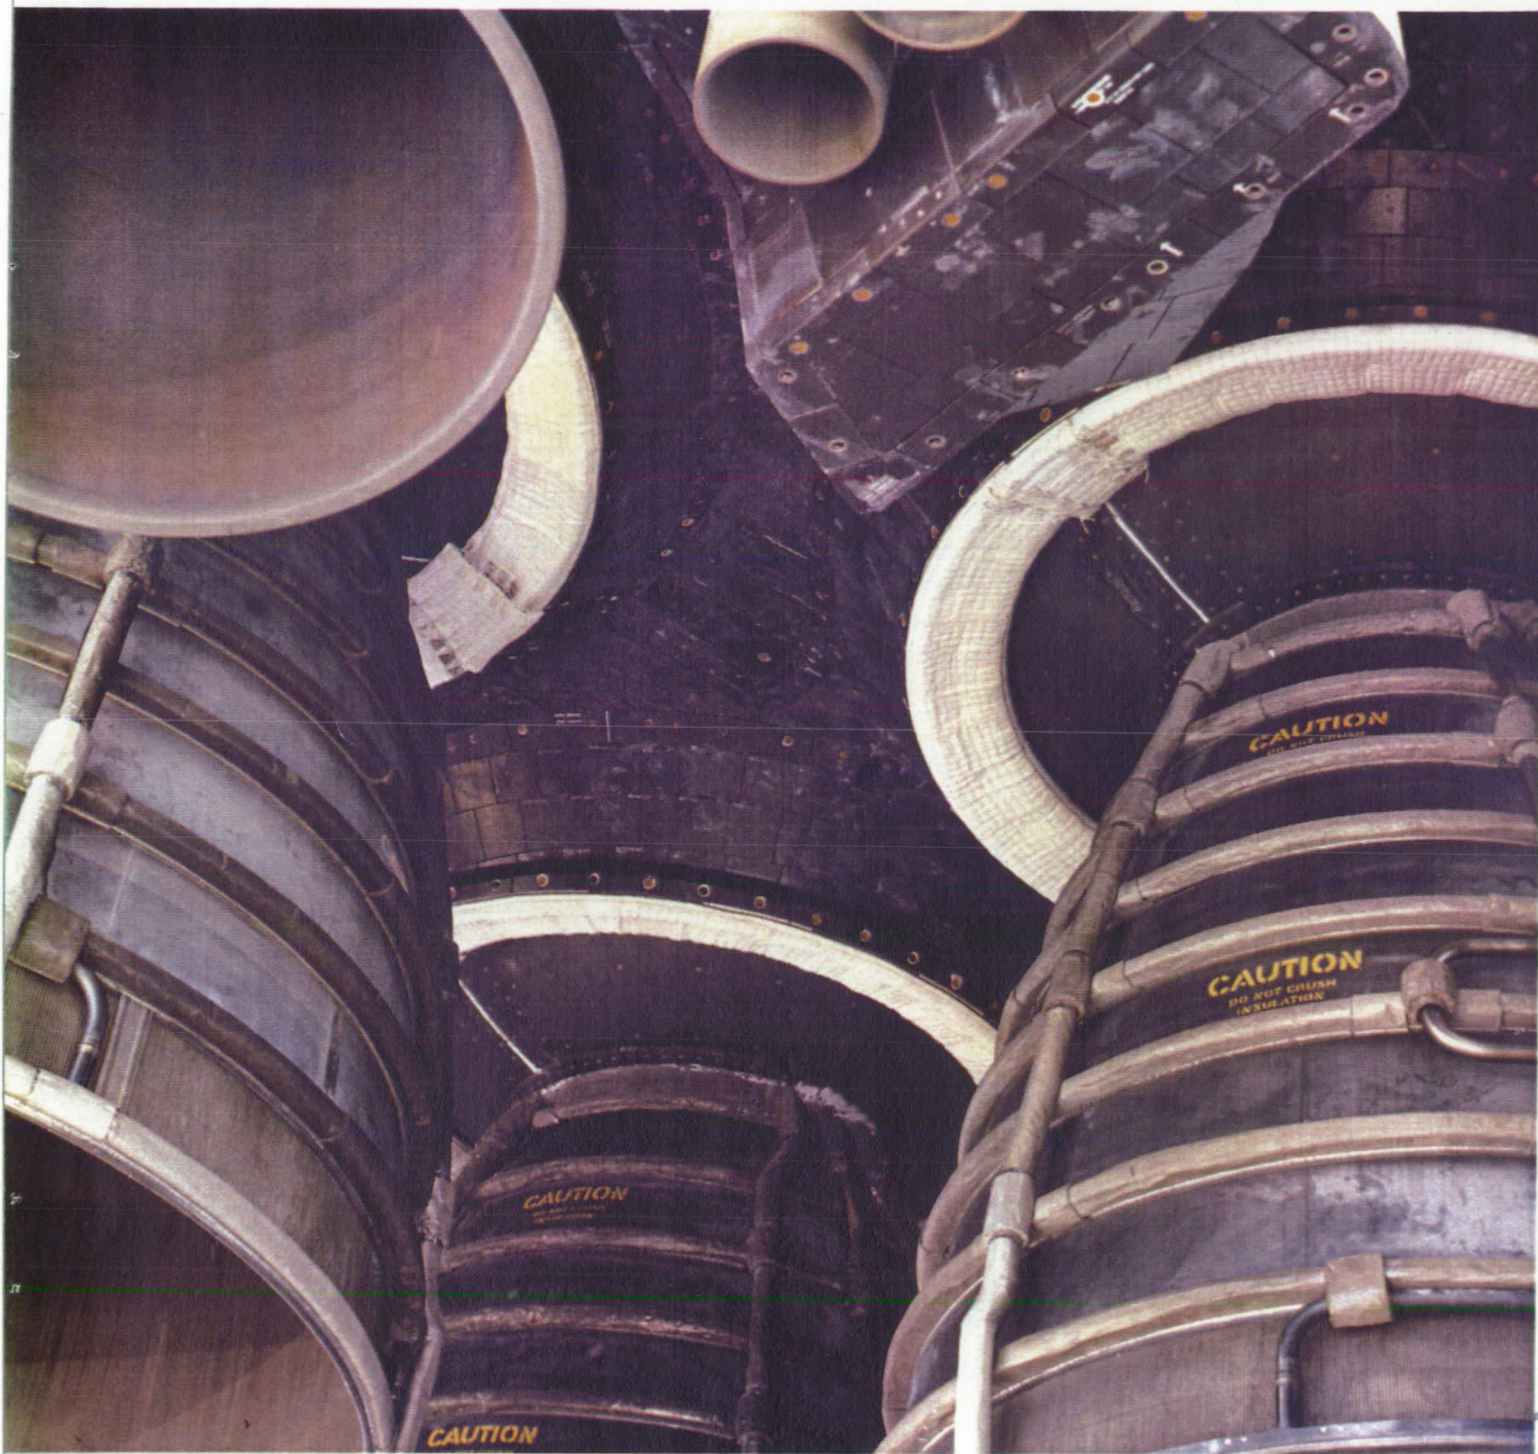
Overall view of SSME cluster. Some ice/frost had formed at the SSME #2 heat shield-to-nozzle interface.

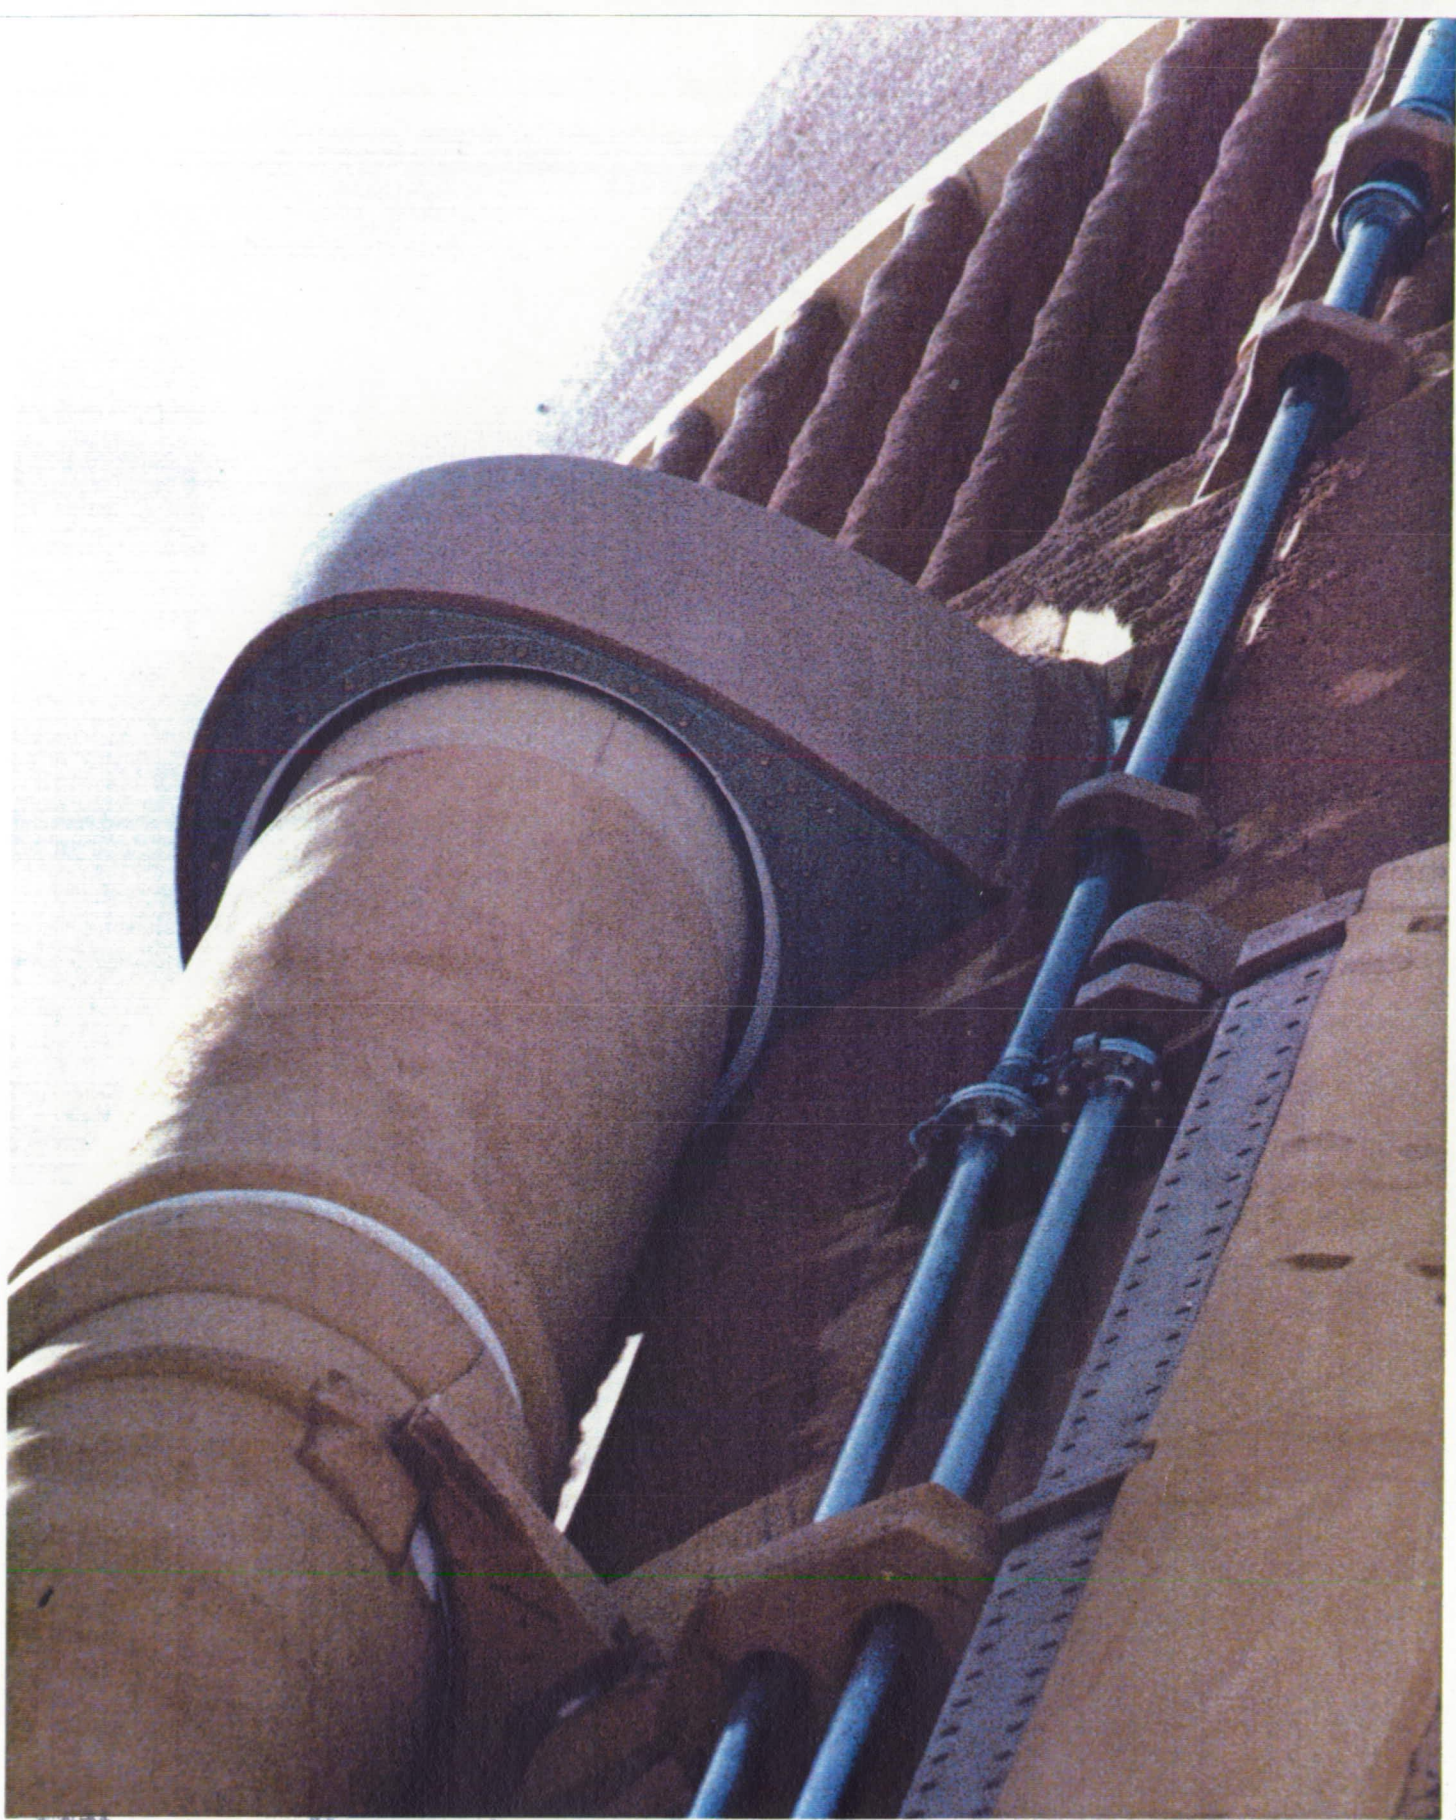
Ice/frost accumulations in the L02 feedline upper bellows
and support brackets were typical

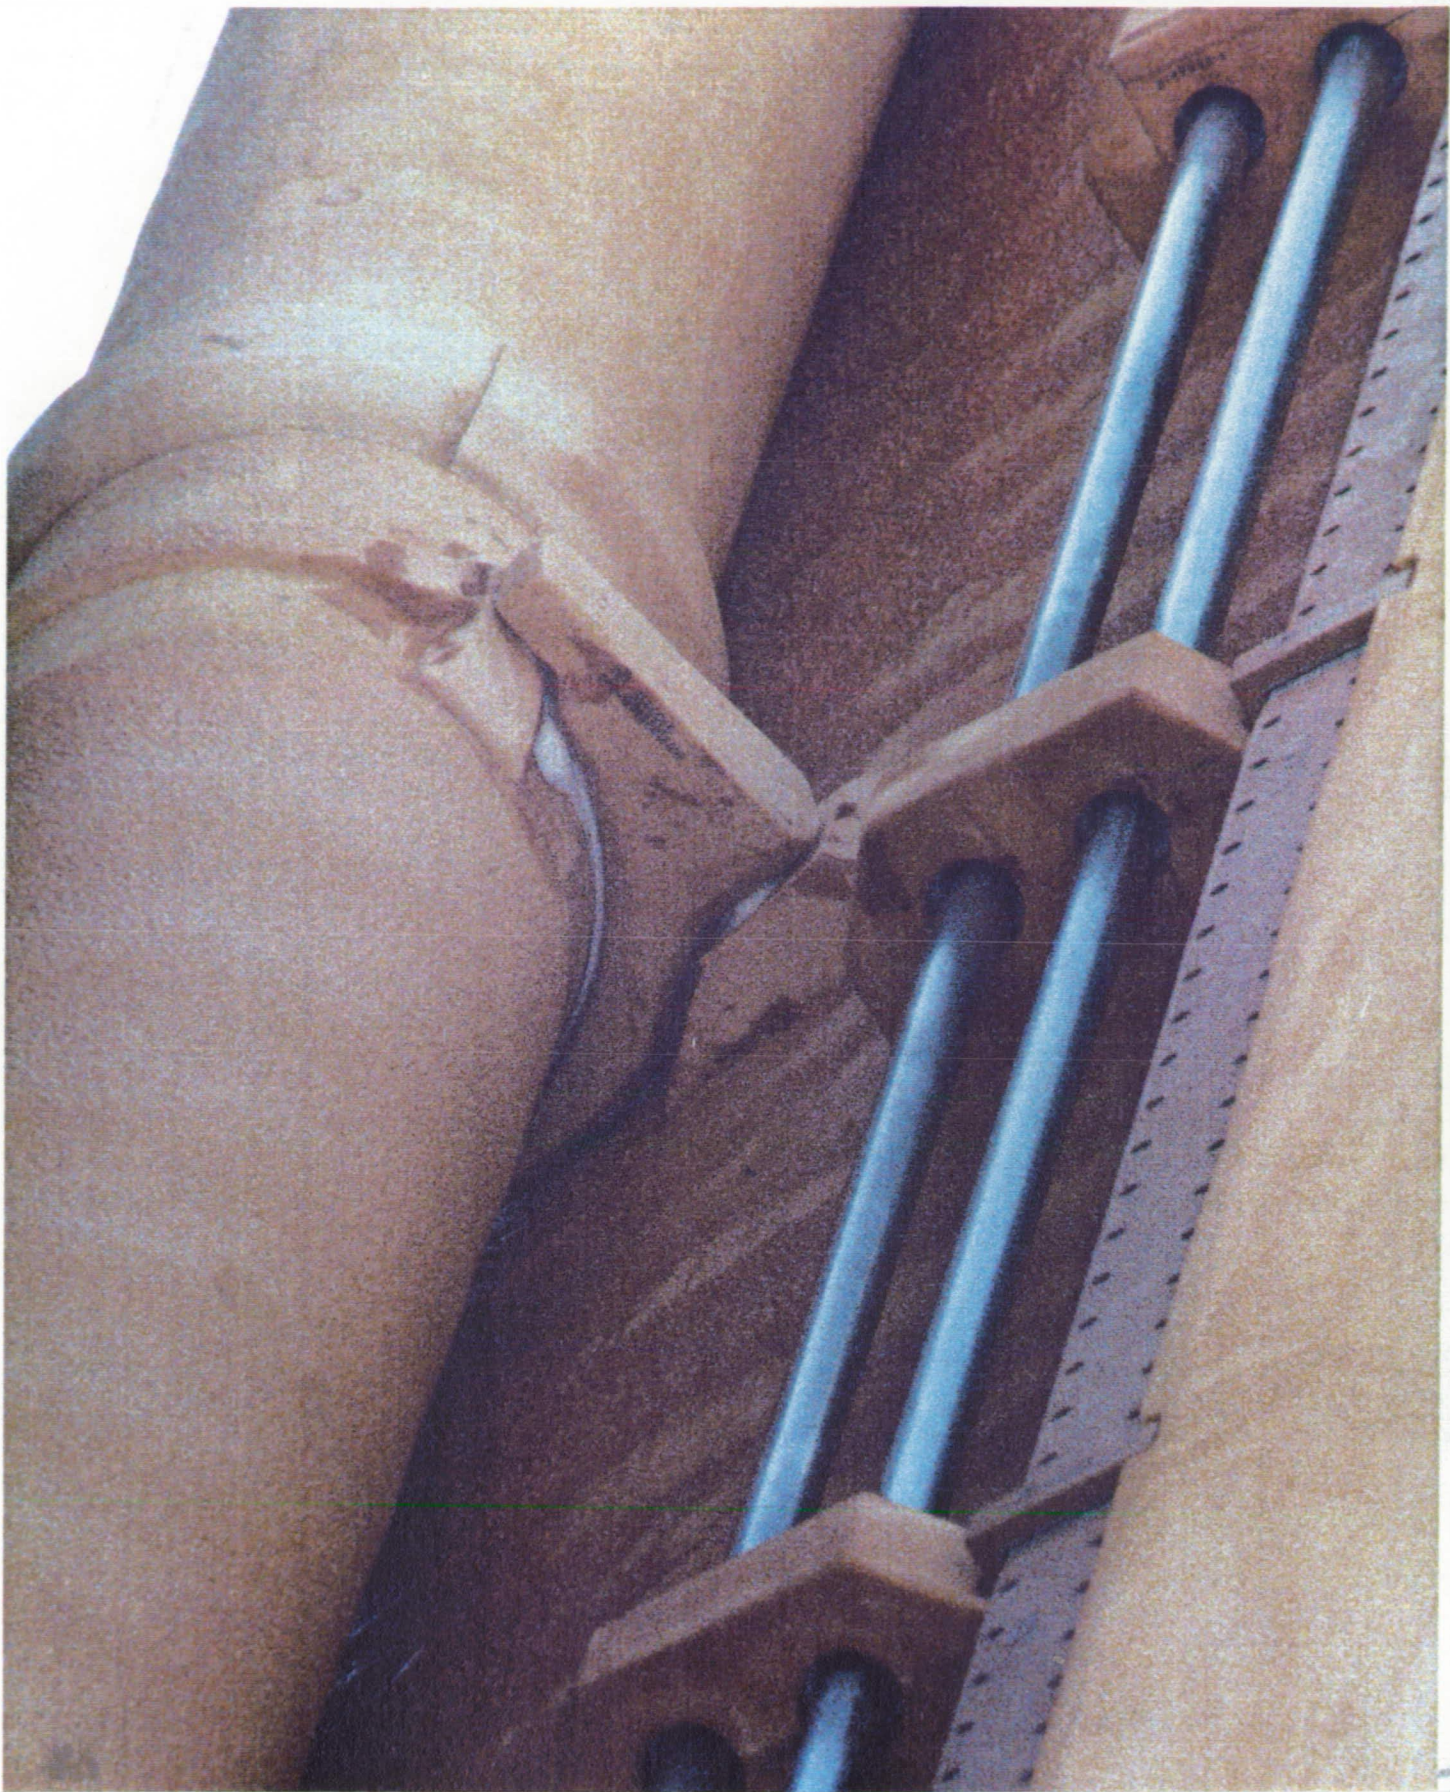
Ice/frost formations in the L02 feedline support brackets
were typical

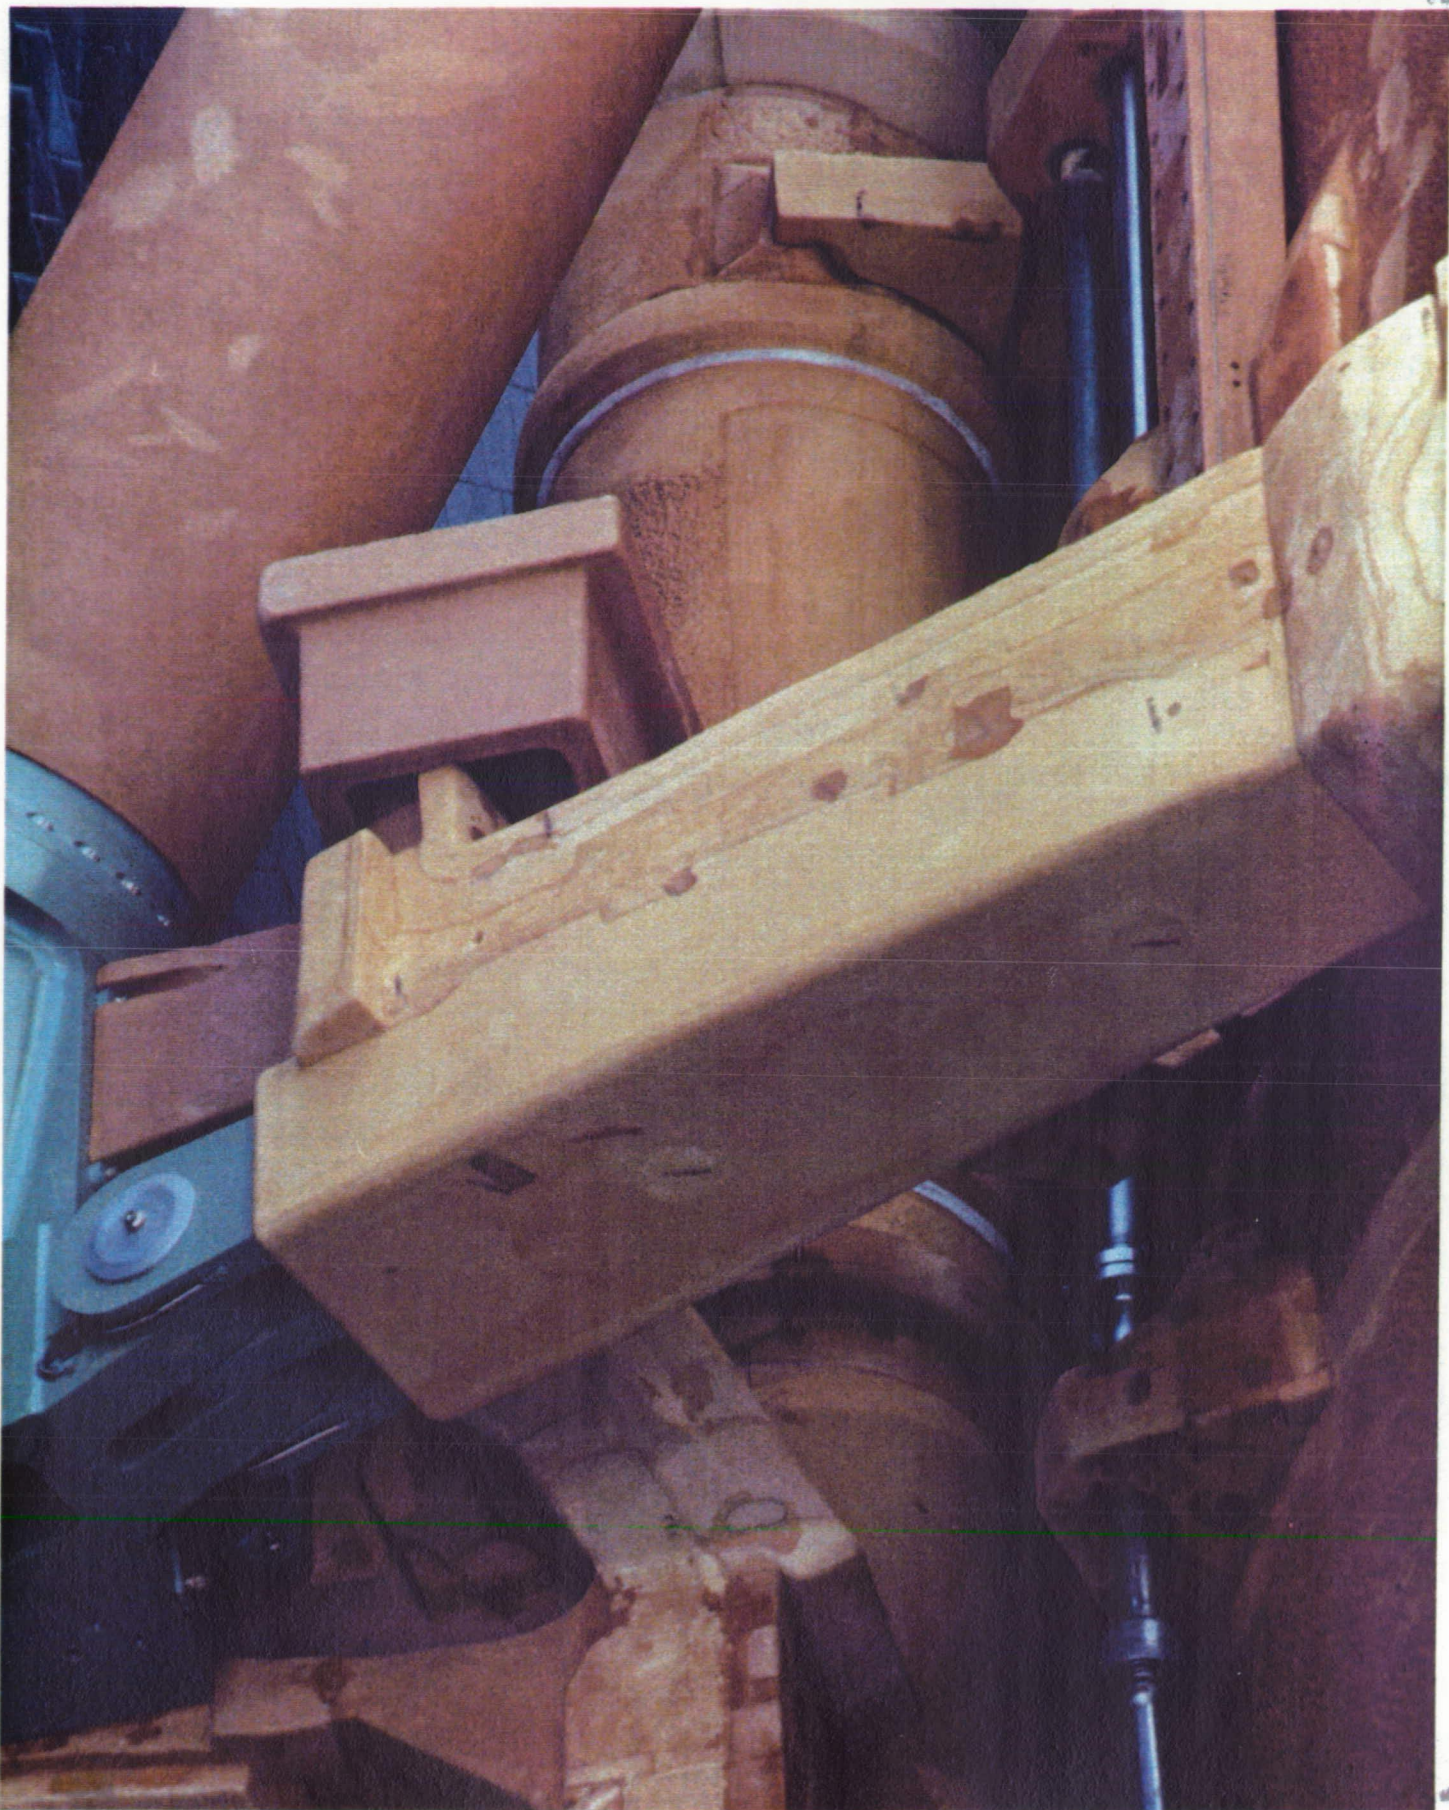
Ice/frost formations in the L02 feedline lower bellows
and support brackets were typical

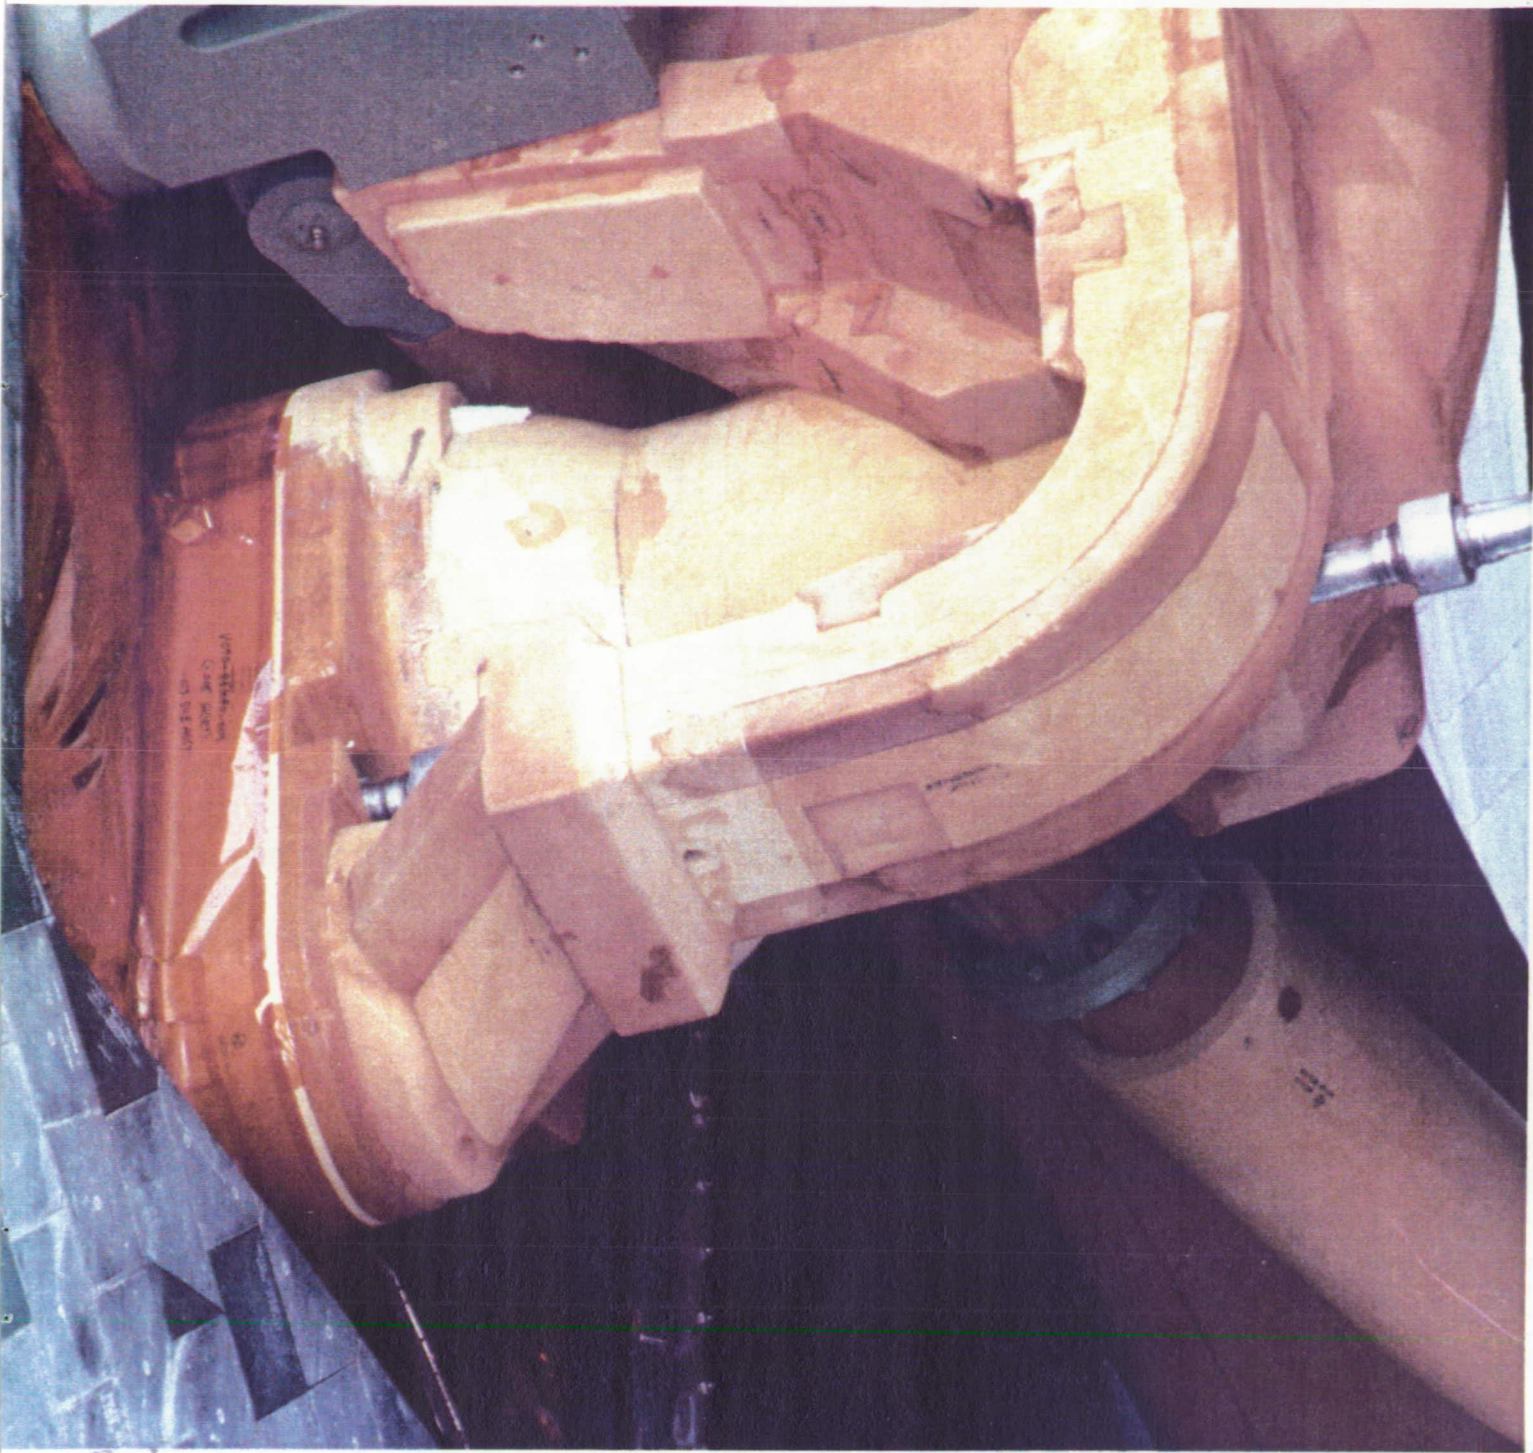
Overall view of the L02 ET/ORB umbilical. Ice/frost fingers on the pyro canister purge vents were typical. There were no acreage TPS anomalies or ice/frost accumulations.

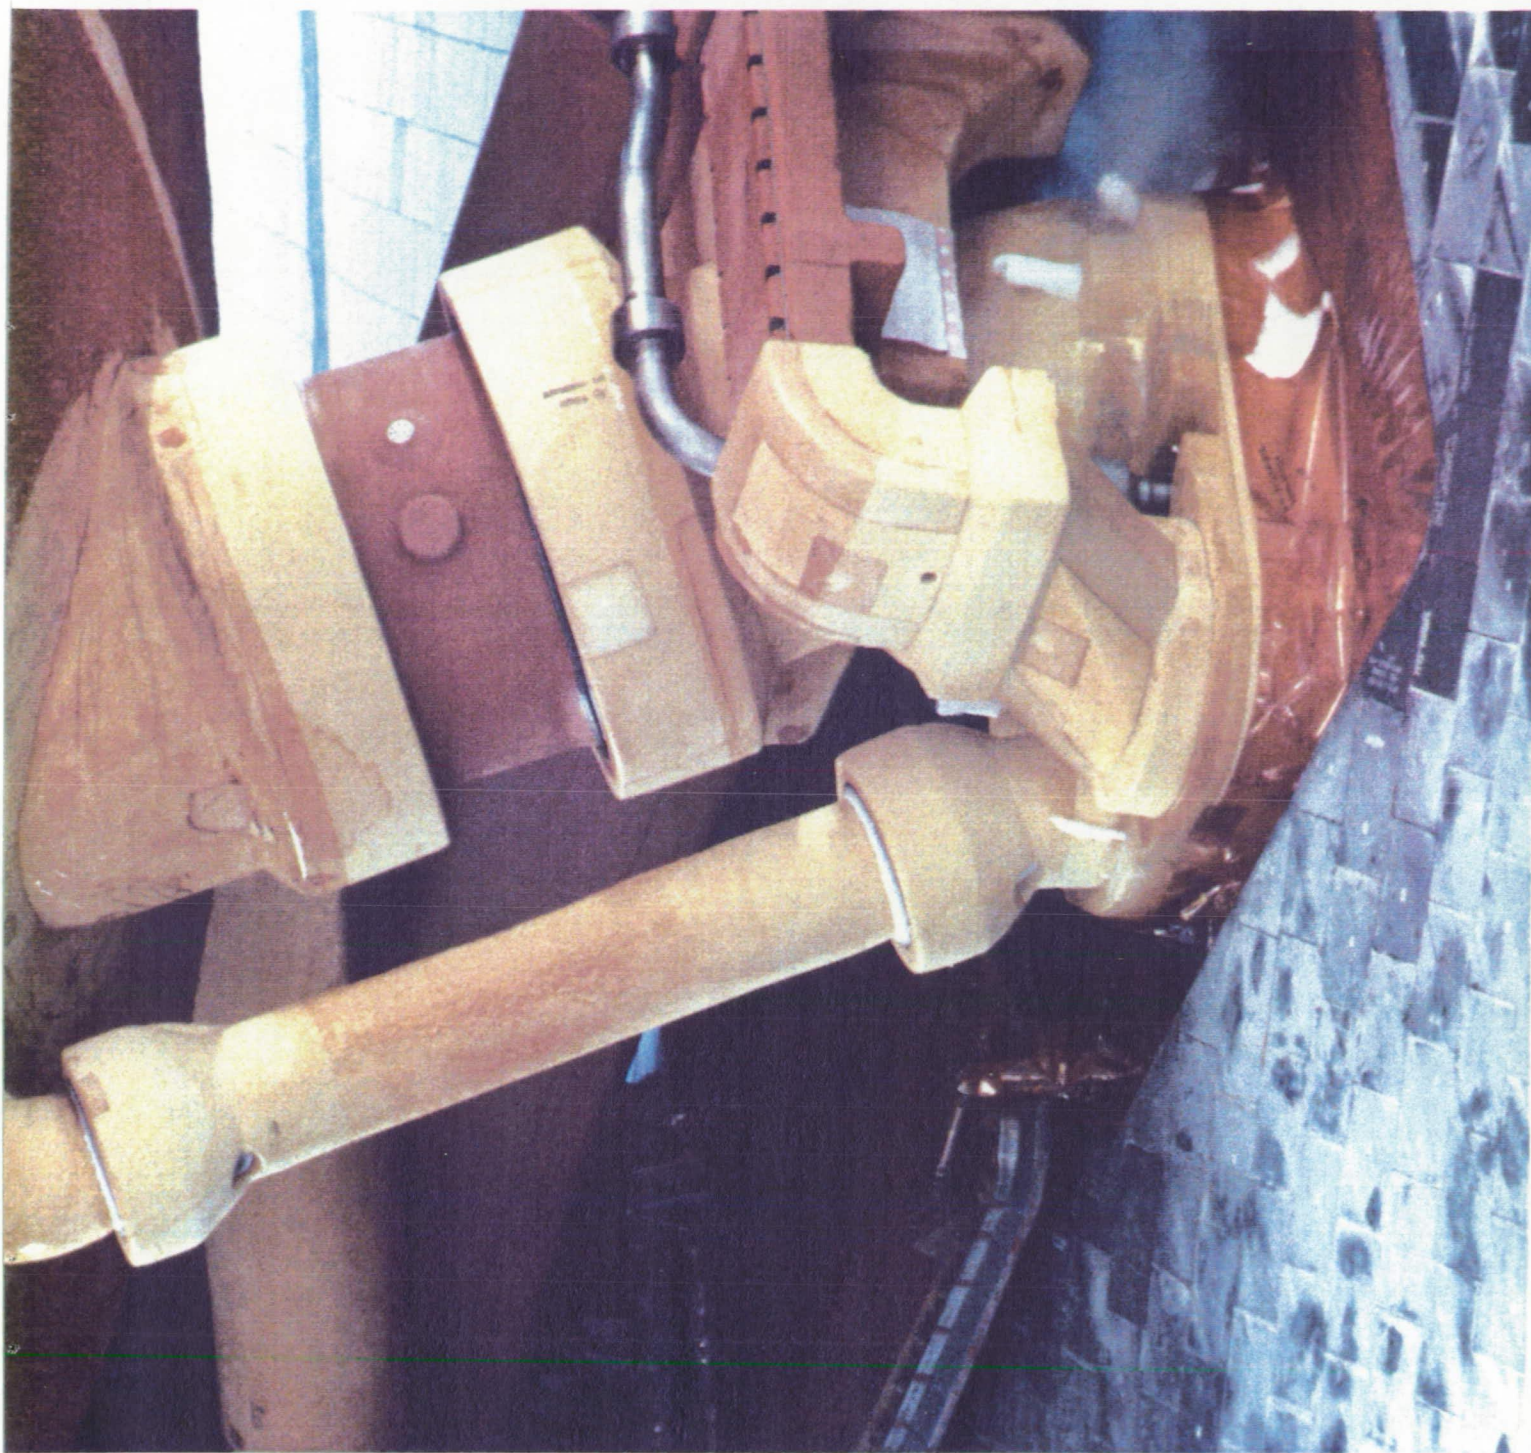
Overall view of the LH2 ET/ORB umbilical. There were no unusual vapors emanating from the umbilical nor any evidence of cryogenic drips. Ice/frost accumulations on the umbilical out board side and on the purge vents were typical. Ice/frost in the recirculation line bellows and burst disks was typical.
